## IMPACT OF THE CRACK IN THE ANGULAR WELDED JOINT ON THE EXPLOITING BEHAVIOUR OF THE CARRYING STRUCTURES MADE OF IMPROVED STRENGTH STEEL

Milenko Perović  
Chamber of Economy of Montenegro  
Novaka Miloševa 29/II, Podgorica,  
Montenegro

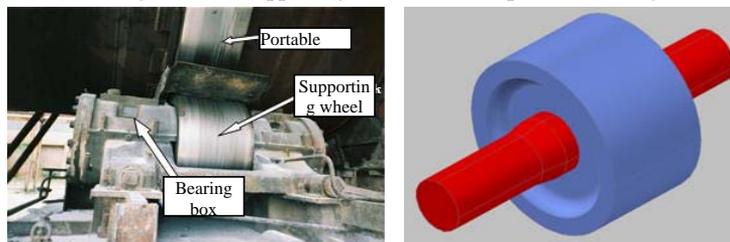
Figure 1. Appearance of carrying station in exploitation and 3D image of supporting system

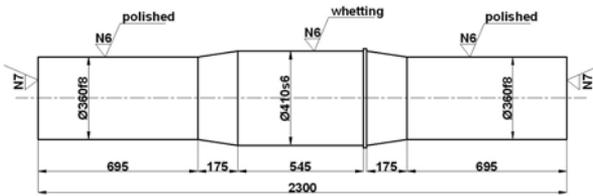
Figure 2. Axle scheme

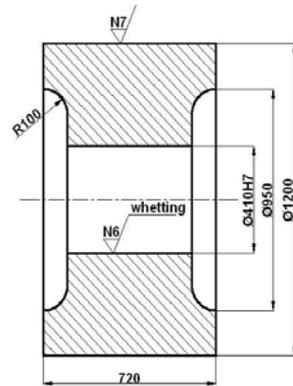
Figure 3. wheel scheme

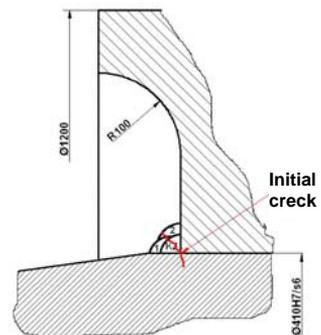
Only after a couple of days after completion of works, construction is mounted in place of mounting. After several working hours, they heard sound of the axle fracture in welding place to supporting wheel. Crack position in angular welded joint schematically is presented on Figure 4, and appearance of assembly after fracture is presented on Figure 5.

Figure 4. Crack position

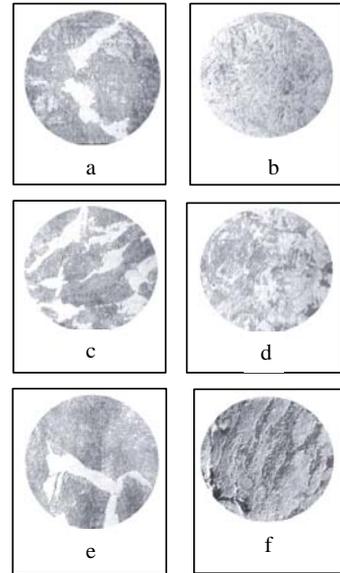
Microstructure of parent material in this region has been changed in relation to structure of parent material. High scope of microstructural ingredients is present, from ferrite-perlite to martensic and Widmanstatten, or their mixtures, Figure 7. a,b,c,d,e and f. This state of structure is characteristic for welded joints made by using additional material based on non-alloying steels.

Figure 7. Welded joint microstructure.

The hypothesis in case of evaluation of possible causes for axle failure of supporting wheel has proved to be correct. Testing shows that use of non-alloying additional materials for welding of steels that are prone to incandescence, without applying of precaution measures, has catastrophic consequences. Therefore, special attention should be paid to the following [4]:

- Selection of material and thermal processing in every phase of making of elements being exposed to various load,
- Functionality of existing structural solution for prevention of unwanted movements of elements in pressed assemblies.
- Quality of processed surface in the contact area of axle and supporting wheel must be high in order to prevent occurrence of additional source of stress concentration caused by roughness.
- Welding technology of steels that are prone to initiation cold cracks for the case where other solutions of forming inseparable link are not feasible or impossible to attain.
- Size of overlap should be such that pressing stresses in contact area are not higher than stresses that are result of external load on elements.

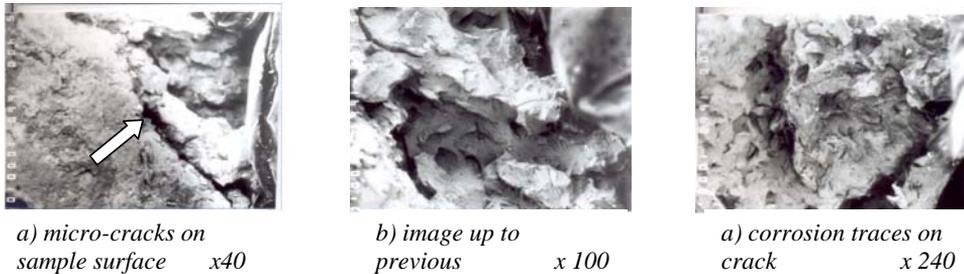
Specimens for fractographic analyse fracture surface are taken from places presented in Figure 6. (immediately bellow material of angularly weleded joint). Analysis is conducted on scanning microscope type JEOL-JCXA-733. Due to presence of local corrosion products, samples are, after cleaning in alcohol and acetone, steamed with gold in order to provide their electrical conductivity. The samples are observed with magnifications of 40-3000x, [3]. Analysis of the external part of sample indicates that it is possible to observe presence of cracks occurred in various time intervals. Some of them are completely free of oxides and others have sticky skim which may indicate, inter alia, various time of their initiation. Figure 8. a, b, and c. By scan analysis of surface fracture, with bigger magnifications (up to 3000x) we can see that fracture appear to be in form of mixed fracture. There are forms of inter – crystalline and trans-crystalline fracture with observable development of secondary and tertiary cracks. Further inspection of the sample towards the core of axle, indicates that the structure is crystalline with big number of flat areas and stairs oriented towards the propagation of primary crack. This state is specific for trans-crystalline crack that begun with cutting or shear mechanism, Figure 9. a, b. These forms, in morphological sense, represent shapes similar to river networks and fish bones that have specific initiation mechanisms and are characteristic for trans-crystalline, Figure 9.c, d.

Figure 8. Micro-fractography of crack surface in in the sample located immediately to welded joint

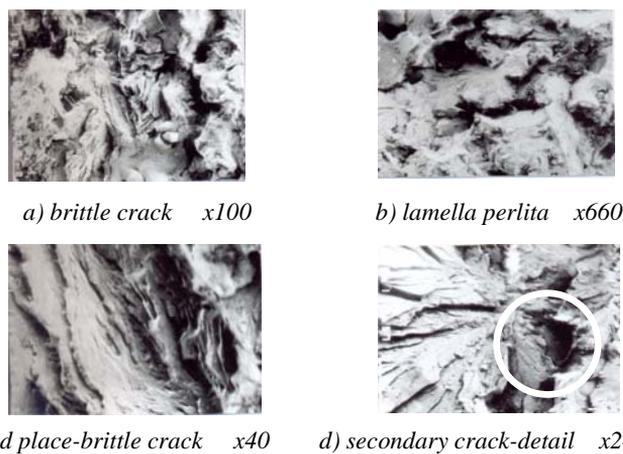
Figure 9. Micro-fractography of crack surface in the sample located towards axle core.

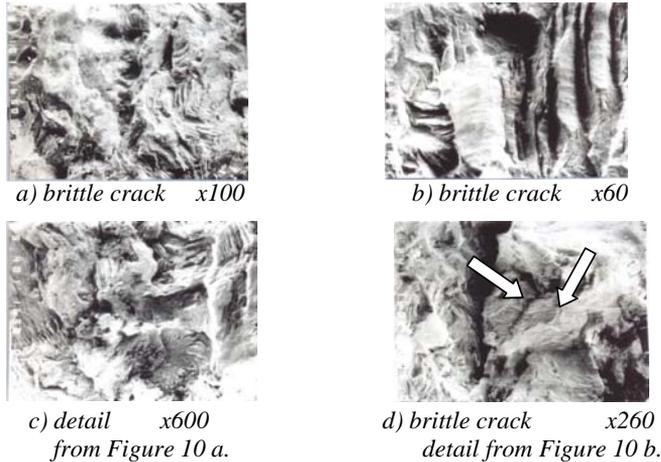
Further inspection, towards the core of the axle, indicates that macro-feature of crack is typically brittle and micro-analysis of crack fractography indicates typical exclusive brittle crack. Microscopic properties of crack surface are in shapes of flat areas, river networks, staircases, fish bones etc. They are present in entire tested surface of the sample and are followed by tiny secondary cracks that are locally inter-crystalline, Figure 10. a,b,c,d.

Figure 10. Micro-fractography of crack surface in axle core

None of three tested specimens shows elements of tough crack in any part. Here we have classic example of sound brittle crack, where trans-crystalline shape dominates.
