ANALYSIS OF GEAR DAMAGE CAUSES USING MICROHARDNESS AND METALLOGRAPHIC TESTING

Different types of damage can occur on the coupled teeth of gears. This paper presents the procedure for testing and analysis of the causes of hip gear teeth from a crane gearbox. The goal of this research was aimed to examine and to analyze the faults that occurred in the damaged teeth of gears made of steel E335 by BAS EN 10027-1 (Č.0645) and to determine what led to the formation of these defects. Experimental part of this research was performed by sampling from three selected gear tooth samples. Two teeth were damaged and there was one undamaged gear tooth. Metallographic and mechanical tests were carried out in order to resolve the respective issues, which occurred at the gear teeth sides. The results of metallographic and mechanical tests indicate that the damaged gear teeth were heavily loaded, and they were improperly welded afterwards, which led to the progressive formation of cracks around the side of the tooth.

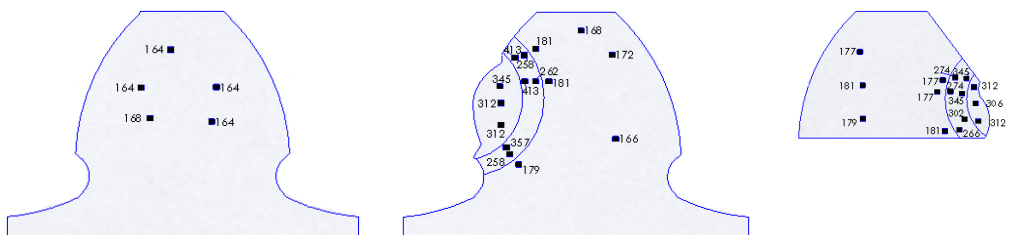
Figure 2. Locations of micro hardness tests

Figure 2 shows locations of micro hardness tests. All gear teeth were tested on locations referred to as a basic material, and damaged teeth (b, c) were tested inside a weld and inside the heat-affected zone. Measurement results, shown in Table 1, show that hardness of undamaged gear tooth is uniform and has value of 164 HV10 across whole cross-section.

Sample (b) was tested in 15 different locations. Basic material has hardness between 166 and 181 (average 17.5 HV10). Lowest hardness 166 HV10 is registered in the middle of the sample, and hardness in heat-affected zone increases. The highest value in heat-affected zone is 357 HV10, while average hardness is 326.8 HV10. Within the weld, hardness is between 312 and 345 HV10, and average is 323 HV10.

Sample (c) was measured at 15 locations. Basic material hardness is between 177 and 266 (average 192.8 HV10). Lowest value 177 HV10 is measured in the middle, increasing towards heat-affected zone. Lowest value in heat-affected zone is 274 HV10, and the highest value is 345 HV10, both in gear tooth side. Welded part had uniform hardness with average value 310 HV10.

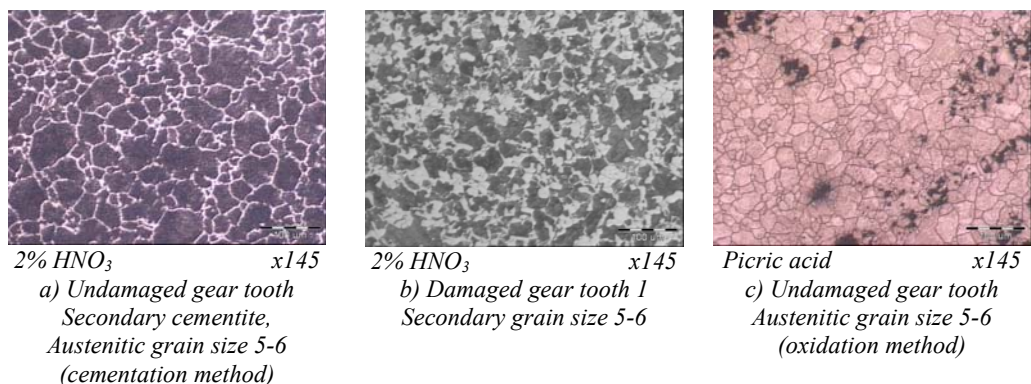
Figure 4. Metallographic test results

Fig. 4 shows results of metallographic tests. Undamaged gear was tested by cementation method (Fig. 4.a). The carbon defunded by grain edges and formed mesh of secondary cementite (Fe₃C). Secondary grain size was tested by method ASTM E112 (Fig.4.b). Undamaged tooth was tested by oxidation

method (Fig.4.c). The microstructure is inhomogeneous and the surface is oxidised. The grain size is 5-6. These tests showed lack of hardened surface and damaged gear teeth had heat-affected zones. Microstructure in all samples was ferrite-pearlite, with grain size 5-6, which provides good mechanical characteristics.

Metallographic examination revealed the absence of a hardened surface, and the two damaged gear teeth expressed existence of the heat effect zone and weld metal in the area on both tooth sides. These two damaged gear teeth also expressed dent in the side of the tooth that was filled with oxide. The microstructure of all three tested samples showed a uniform ferrite-pearlite structure. The secondary grain size on all three samples is between 5 and 6. To assess the size of austenite grains, detection of austenitic grain was performed using Mc Quaid – Ehn method of carburisation followed by etching with 2% HNO_3 solution and the oxidation method was performed with picric acid etching. Testing of austenitic grains of all three samples of gear teeth revealed medium grain size, between 5 and 6, which guarantees favourable mechanical properties.

The working life of the this gear would be significantly extended if the gear teeth were surface-hardened or cemented.
