RESEARCH INTO THE EFFECT OF CORROSION ON DAMAGED THERMAL POWER PLANT EQUIPMENT

ABSTRACT

The research was conducted at several power plants where defects of boiler exchangers were detected. The analysis of damages on fire tubes and exchangers were performed considering selected materials and influence of different types of corrosion. Critical areas on both the side of flue gasses and the side of water/steam working fluid were considered.

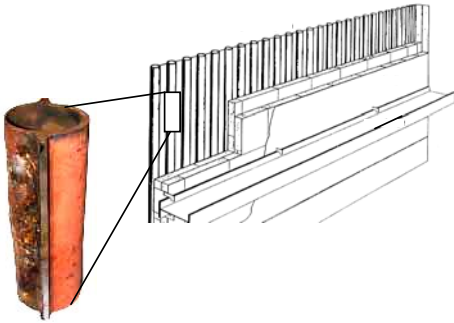
Figure 1. Sample of a tube subjected to testing

By visual examination of the tube outer and inner surface the following is usually detected:

- all along both sides of the tube weld on the fire tube outer surface, deposits of the combustion and corrosion products are formed
- on the other half of the outer surface, insulation side, there are no visible processes of deterioration
- inner side of the tube (water) has no visible changes and defects.

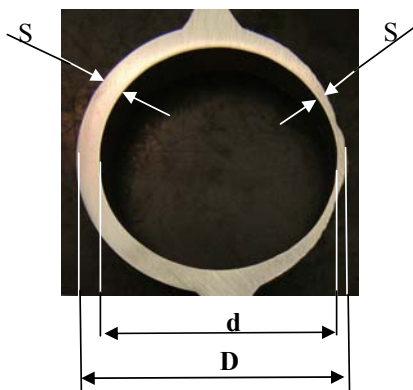
Dimensional tests were carried out on the tube cross section by measuring the outer and inner diameter and the wall thickness as in Figure 3. Nominal dimensions of the tube are: ϕ 60,3 x 5 mm and the testing results are shown in Table 1.

Figure 3. Cross-section dimensional control

| Measuring area | mm | |
|---|---|---|
| S ₁ – tube fire side | 1,9 – 3,8 | |
| S ₂ – insulation side | 5,05 – 5,12 | |

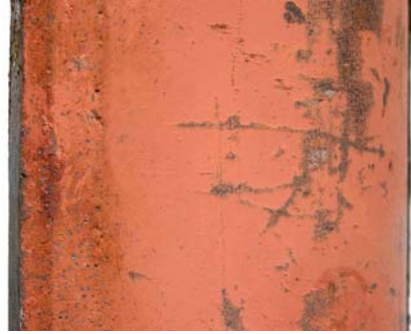
Figure 5 Tube insulation side outer surface

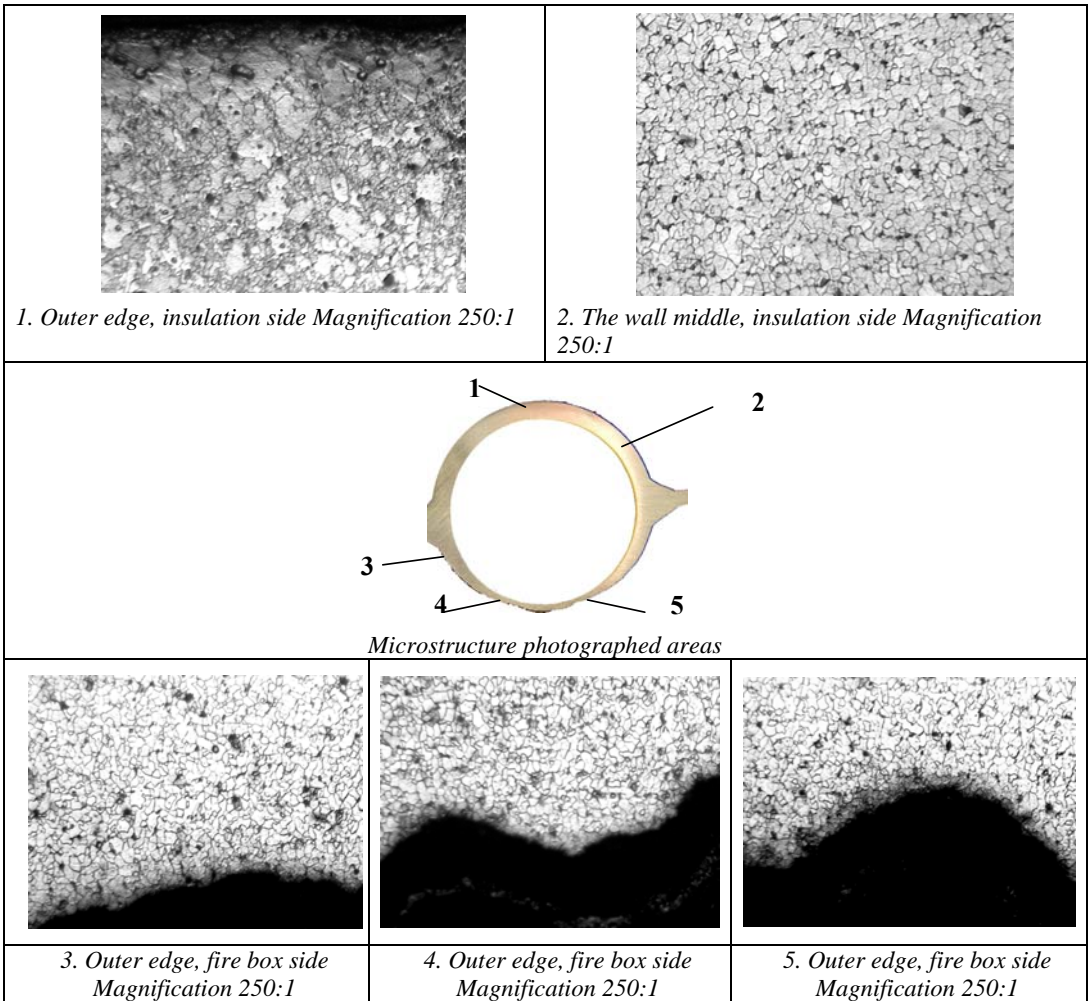
Figure 7 Photographed areas and the damaged tube microstructure photographs

Metallographic tests were performed on the tube cross section in two steps:

- preparation of samples by destructive method
- structure analysis by the Leitz optical microscope

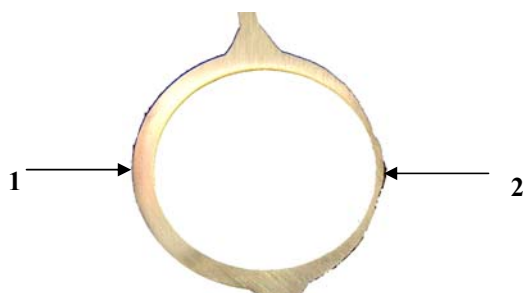
Hardness tests were performed by HV 0,1 method (9,81 N loading). Tested areas are shown in Figure 6. Area 1 is on the tube cross section insulation side that is not damaged by corrosion. Five percent

measurement was carried out on this part from number 1 (wall outer edge) to number 5 (tube wall cross section inner edge) respectively. The same method of measurement was applied to area 2 (damaged side) and the measured values are shown in Table 2.

Figure 6. Hardness test areas
