## RESEARCH INTO THE EFFECT OF CORROSION ON DAMAGED THERMAL POWER PLANT EQUIPMENT

*The research was conducted at several power plants where defects of boiler exchangers were detected. The analysis of damages on fire tubes and exchangers were performed considering selected materials and influence of different types of corrosion. Critical areas on both the side of flue gasses and the side of water/steam working fluid were considered.*

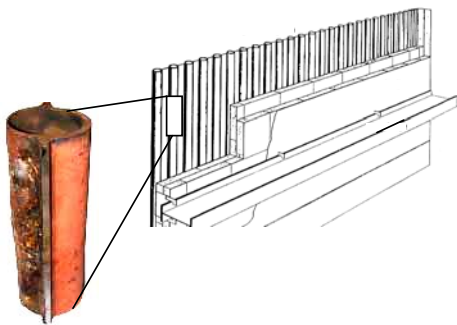
Figure 1. Sample of a tube subjected to testing

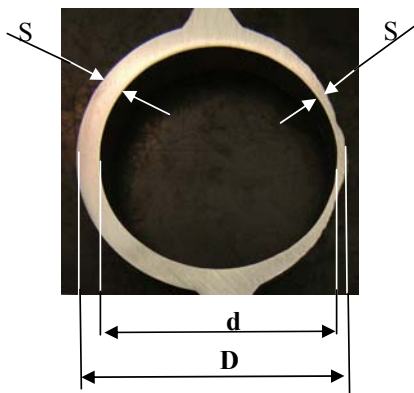
Dimensional tests were carried out on the tube cross section by measuring the outer and inner diameter and the wall thickness as in Figure 3. Nominal dimensions of the tube are:  $\phi$  60,3 x 5 mm and the testing results are shown in Table 1.

Figure 3. Cross-section dimensional control

Measuring area	mm	
	min.	max.
d	48,8	49,7
D	56,6	58,2
S <sub>1</sub> – tube fire side	1,9 – 3,8	
S <sub>2</sub> – insulation side	5,05 – 5,12

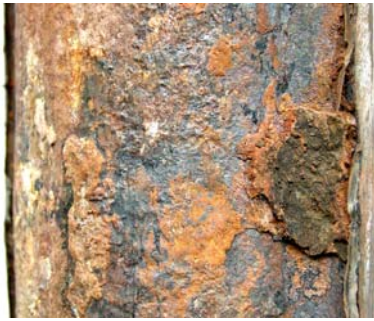
- all along both sides of the tube weld on the fire tube outer surface, deposits of the combustion and corrosion products are formed
- on the other half of the outer surface, insulation side, there are no visible processes of deterioration
- inner side of the tube (water) has no visible changes and defects.

Figure 4 Tube fire side outer surface

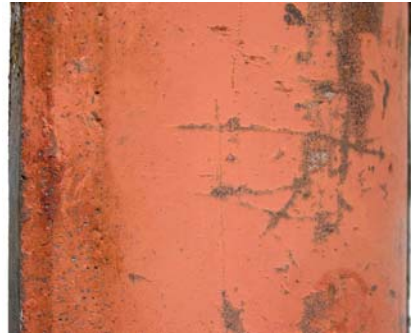
Figure 5 Tube insulation side outer surface

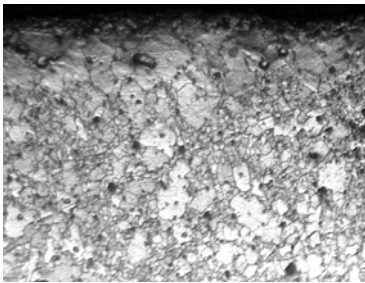
1. Outer edge, insulation side Magnification 250:1

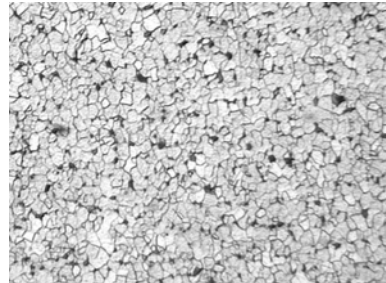
2. The wall middle, insulation side Magnification 250:1

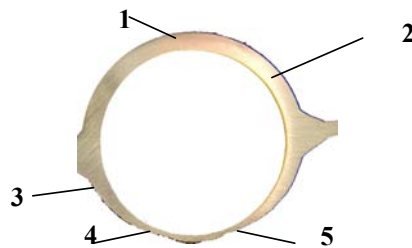
Microstructure photographed areas

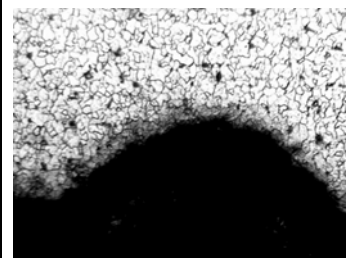
5. Outer edge, fire box side  
Magnification 250:1

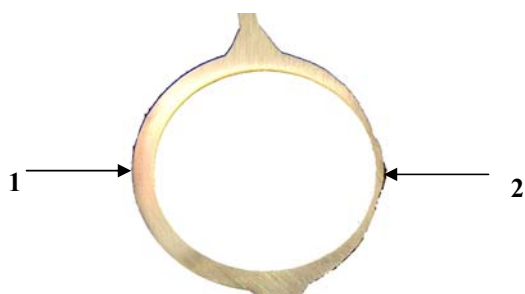
Hardness tests were performed by HV 0,1 method (9,81 N loading). Tested areas are shown in Figure 6. Area 1 is on the tube cross section insulation side that is not damaged by corrosion. Five percent

measurement was carried out on this part from number 1 (wall outer edge) to number 5 (tube wall cross section inner edge) respectively. The same method of measurement was applied to area 2 (damaged side) and the measured values are shown in Table 2.

Figure 6. Hardness test areas

HV 0,1 (loading 0,981 N)		
Measurement No.	Area 1	Area 2
1.	132	153
2.	145	146
3.	160	142
4.	135	151
5.	128	139
Mean value	140	146,2
