**APPLICATION POSSIBILITIES OF REPAIR WELDING
DURING EQUIPMENT REVITALIZATION
OF TURBINE NO2 AT HE GRABOVICA**

Hydro power plant Grabovica, that is one in the system of hydro power plants on river Neretva, stopped the work, caused of the failure on the turbine no 2. Because of the specific character of damage, as well as the fact that turbine was working for 30 years, management of the power plant is decided to make a general repair of turbine. General repair of turbine is very complex job, that include engagement of different profile experts and companies specialised for this kind of work. Large scale of equipment had to be replaced by new equipment, but another part of equipment can be repaired and thus significantly reduce the total costs. In this paper are presented some possibilities of usage of welding repair technologies and also surfacing by welding on some special turbine parts. In detail will be presented methods of rehabilitation of cavitations on turbine neck and NDT testing and repairs of cracks by welding on the turbine blade.

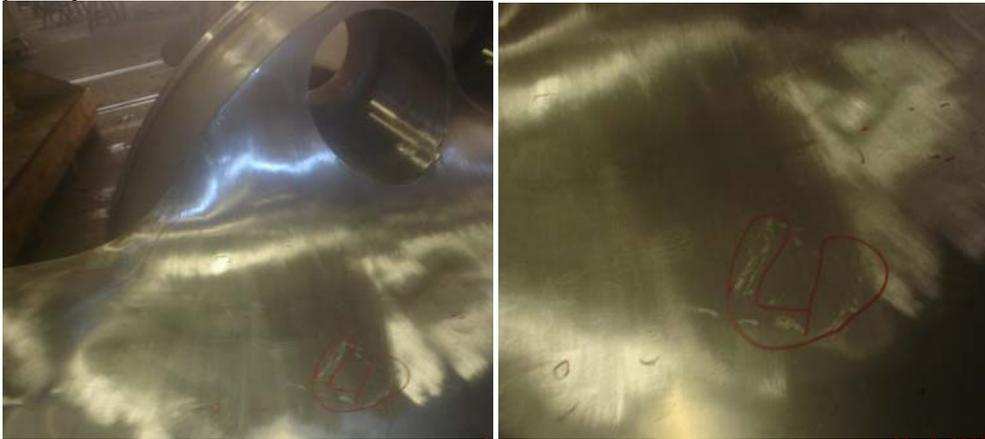
In the producers factory has been done control of the all shoulder blades of turbine. The first control has been done by the methods of magnetic particles, and by this control was detected some smaller porosity on the surface of the blade.

Figure 1. Shoulder blades of turbine with detected places for repairing

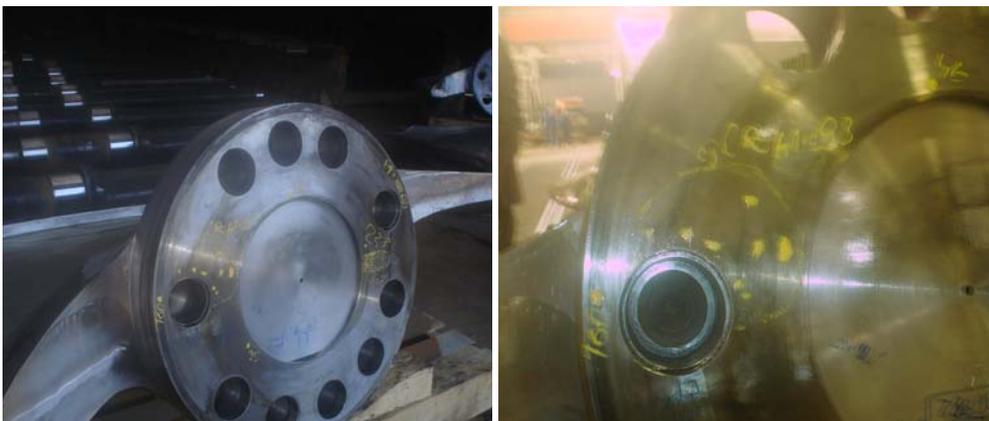
After control of the shoulder blades of turbine by ultrasonic testing it was detected some failures in the homogeneity of material and this locations are marked. The depth of these failures were different, from the surface defects till to the defects on the depth of 350 mm. Shape and dimensions of defects don't refer that its repairing would be necessary.

Figure 2. Shoulder blades of turbine with detected places with material non-homogeneity

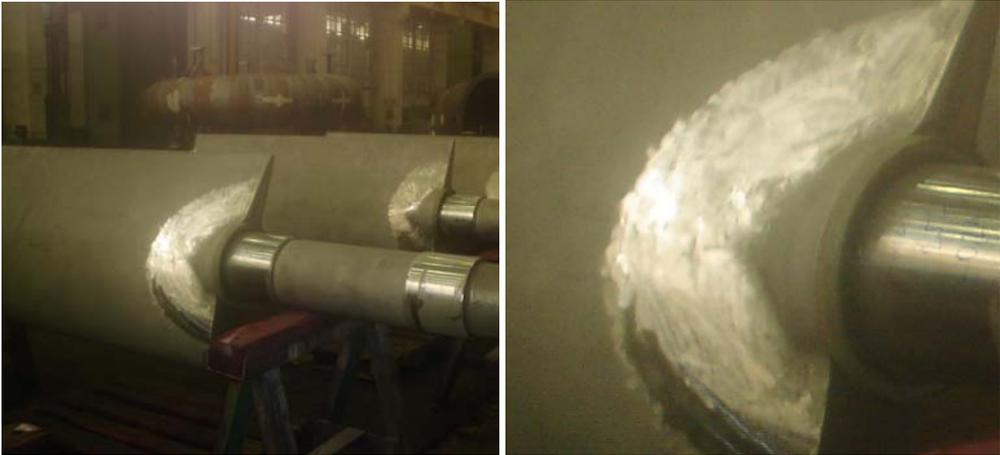
Before testing all the blades had to be cleaned, and places that are evaluated as the most critical for possible location of the material non-homogeneity, before testing has been polished, fig. 3.

Figure 3. Cleaned and polished blades with marked places that has been the first priority for ultrasonic testing

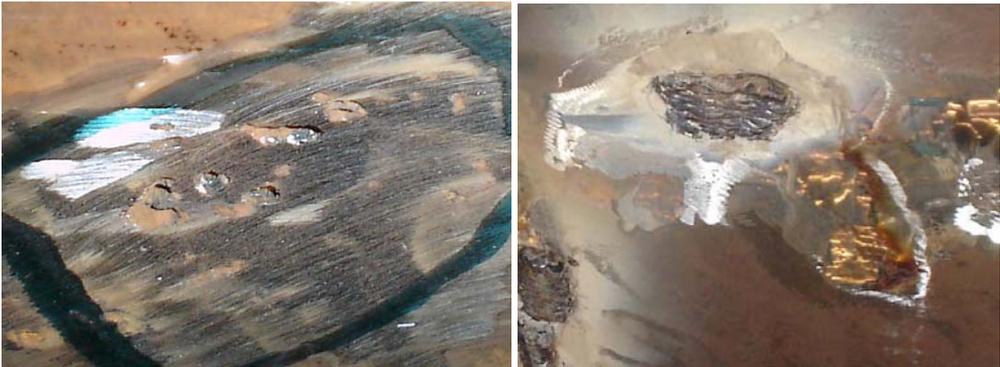
In the scope of the general repair of aggregate no2, some parts of equipment which were stayed in the hydro power plant Grabovica has been controlled by methods of non-destructive testing NDT (blades of stator, segments of bearings and similar parts). Visual control of some segments of turbine and parts of diffusers is shown a certain damaged areas by the cavitations. The period of the reparation of aggregate no2 is used for reparation of all these damaged elements. Usual methods for the repairing of this damaged areas is welding surfacing and for this case of repairing shielded metal arc welding (SMAW) procedure was chosen.

Figure 5. Marked areas with cavitations

On the base of chemical composition and mechanical properties of the base material, the logical choice would be an electrode that will give welded deposit with approximately similar chemical composition and mechanical properties like base material. However, taking into account really difficult conditions for welding, as well as relatively high humidity, basic coated low alloyed electrode could not be appropriate choice. Because of the corrosion problems and requirements for improvement of mechanical properties of welded joints, high alloyed electrode INOX R18/8/6 Fe was chosen. This kind of electrode is recommended for the following case of welding:

Taking into account all factors it was decided that damaged areas should be repaired using shielded metal arc welding (SMAW) procedure by coated electrode. In respect to the carbon content of base material and thickness of the parts, preheating temperature is calculated in accordance to the Seferian method and it was about 250 °C. Before the welding all damaged areas was prepared by mechanical grinding. Technological parameters of welding are given in the table 3.
