REPAIR OF A DAMAGED PART ON HYDRAULIC TRACT KAPLAN TURBINE WITH "LIQUID METAL"

Fuad Ćatović, prof. emeritus
Edin Džih, MSc
University „Džemal Bijedić“
Mostar, BiH

Mustafa Šehić
Hydroelectric power plant Neretva
Jablanica, BiH

During 2011 on unit no.2 repair work was carried out aimed at fault removal on Kaplan turbine impeller, while extending the lifespan of the entire installed equipment. The overhaul included all vital parts, replacement of all gasket compresses, machine processing to achieve the required tolerances, NDT equipment control according to "Quality Control Plan", repairing equipment, etc.

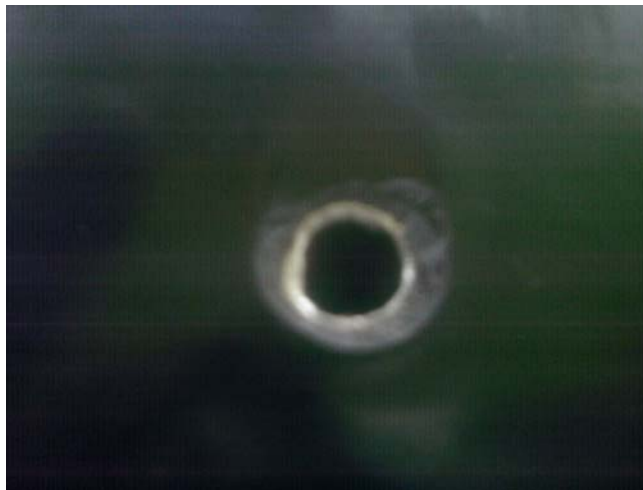
Picture 1.

In all technological processes the first phase of repair of parts and assemblies is the inspection of damage which is necessary in order to determine the detailed dimensions of the defects on the equipment which is being reviewed. On the blades of no. 18 and 24 on the guide vanes a damage on the inside of the blades was observed. Dimensions of the damage were $\varnothing 5$ [mm up to $\varnothing 7$ [mm diameter, and with a depth of $h - 2$ [mm to $h - 6$ [mm, shown in picture no. 1. The damage, on one hand, should be repaired with as less heat input and machining as possible, and on the other hand, the repaired part is supposed not to affect the reliability of the unit in the future.

After the visual inspection and recording of damage of the blades of the guide vanes, an ultrasound examination of the blades has been required. Ultrasound examination was performed in order to determine the exact shape of the defects, or whether and to what extent the surface damages left its mark below the surface of the blades. After the results of the ultrasound examination, no further grinding of surface below the defect was necessary, the structure of the material below the defect surface was in a satisfactory condition.
