EXPERIMENTAL IDENTIFICATION OF DYNAMIC BEHAVIOR OF VIBRATING SCREEN IN COAL MINE SEPARATION DEPARTMENT

Nedeljko Vukojević, Fuad Hadžikadunić
Faculty of Mechanical Engineering
Fakultetska 1, Zenica
Bosnia and Herzegovina

Mustafa Imamović
ArcelorMittal Zenica
Bulevar Kralja Tvrtka I No.17, Zenica
Bosnia and Herzegovina

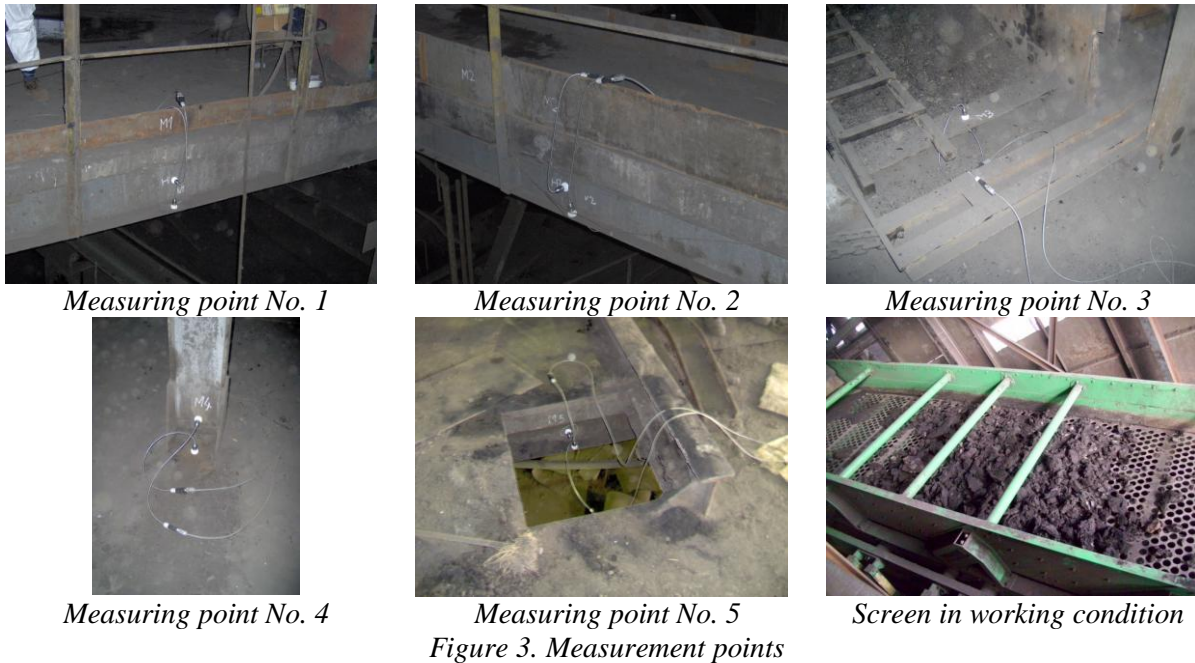
Measurements of the dynamic behavior of the vibrating screen Vibratech type VBS-2D was made in working conditions, Figure 3. Acceleration sensors were installed in two orthogonal planes at several measuring points. For data acquisition device is used Spider 8-55 manufacturer HBM, and data processing is done in software Catman Professional.

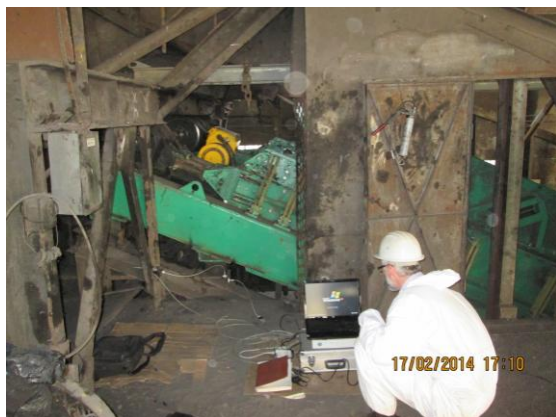
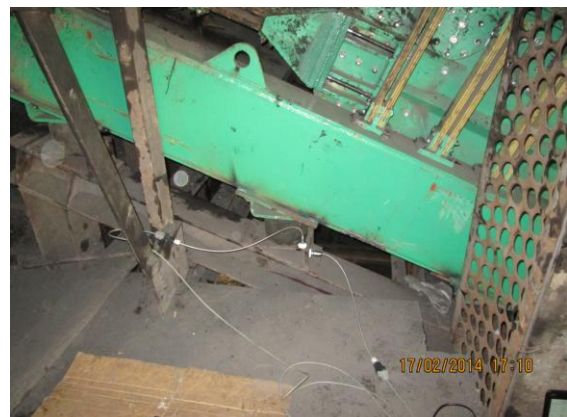
Measurements of acceleration on the vibrating screen after changes to the chassis are made only in characteristic measuring points in the most extreme operating conditions. These test points are selected based on the results of extensive measurements and analysis of the screens before the change of chassis and other facilities in different operating conditions, Figure 3. Cumulative results are shown in Tables 1 and 2. Measurements are made on the vibrating screen after changes to the chassis in the same place as in vibrating screen "HEIN-LEHMANN" type LS2-26DD, Figures 4 and 5.
