# ANALYSIS OF GEAR DAMAGE CAUSES USING MICROHARDNESS AND METALLOGRAPHIC TESTING

# ABSTRACT

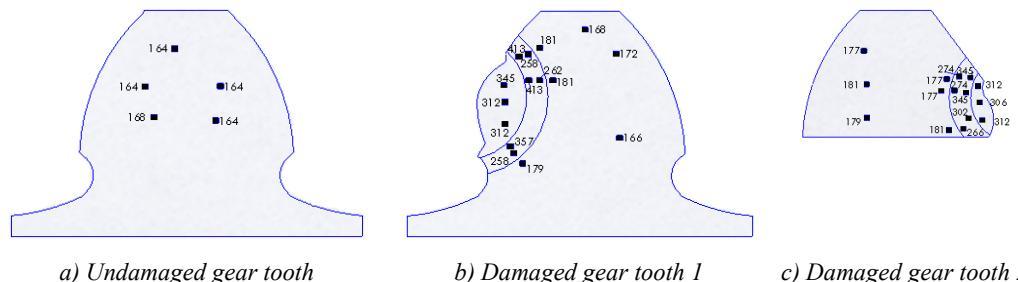
Figure 2. Locations of micro hardness tests

Figure 2 shows locations of micro hardness tests. All gear teeth were tested on locations referred to as a basic material, and damaged teeth (b, c) were tested inside a weld and inside the heat-affected zone. Measurement results, shown in Table 1, show that hardness of undamaged gear tooth is uniform and has value of 164 HV10 across whole cross-section.

c) Damaged gear tooth 2

Sample (b) was tested in 15 different locations. Basic material has hardness between 166 and 181 (average 17.5 HV10). Lowest hardness 166 HV10 is registered in the middle of the sample, and hardness in heat-affected zone increases. The highest value in heat-affected zone is 357 HV10, while average hardness is 326.8 HV10. Within the weld, hardness is between 312 and 345 HV10, and average is 323 HV10.

Sample (c) was measured at 15 locations. Basic material hardness is between 177 and 266 (average 192.8 HV10). Lowest value 177 HV10 is measured in the middle, increasing towards heat-affected zone. Lowest value in heat-affected zone is 274 HV10, and the highest value is 345 HV10, both in gear tooth side. Welded part had uniform hardness with average value 310 HV10.

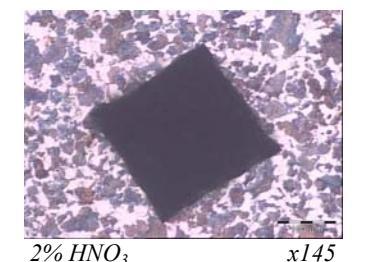
Figure 3. Microstructure of hardness tests

a) Middle of tooth, ferrite-pearlite structure, Hardness HV10:164

b) Weld. Hardness HV10:345

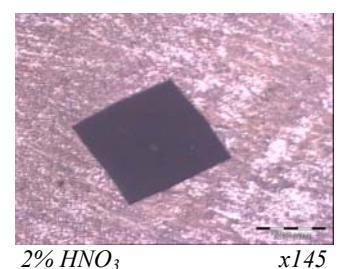
c) Heat-affected zone, Hardness HV10:357
