IMPACT TOUGHNESS OF REGENERATIVE HEAT TREATED STEEL 14MoV6-3

In this paper heat resisted steel 14MoV6-3 in conditions as a virgin, exploited and regenerative heat treated material is investigated. This steel was used for the main steamline of thermal power plant for a prolonged life time period under service conditions. As a consequence of microstructure evolution through long period of exploitation at elevated temperature there was a significant decrease of mechanical properties. Some published investigations reports about possibility of regenerative heat treatment after prolonged exploitation of low alloyed Cr-Mo-V cast steels. Considering this assumption exploited steamline steel 14MoV6-3 is exposed to regenerative heat treatment in order to improve decreased mechanical properties. Microstructure of regenerative heat treated material 14MoV6-3 implicitly indicated increase of strength properties, but not toughness properties at same time. In order to investigate impact toughness following temperatures were selected: 20°C, 150°C, 400°C and 540°C (service temperature) for virgin, exploited and regenerative heat treated steamline steel 14MoV6-3. Further investigation related to reg

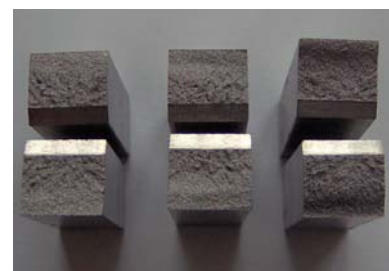
Figure 7. Reg. heat treated material 14MoV6-3 at 20 °C

Tested Charpy V-notch specimens at room temperature (20 °C) of virgin, exploited and regenerative heat treated steamline material 14MoV6-3 are shown in Figures 5, 6 and 7, respectively, [6].
