DAMAGE IDENTIFICATION IN BEAMS USING ADOPTED FUNCTIONAL MINIMIZATION

Elma Ekinović, Nedim Hodžić, Sabahudin Ekinović University of Zenica Bosnia and Herzegovina

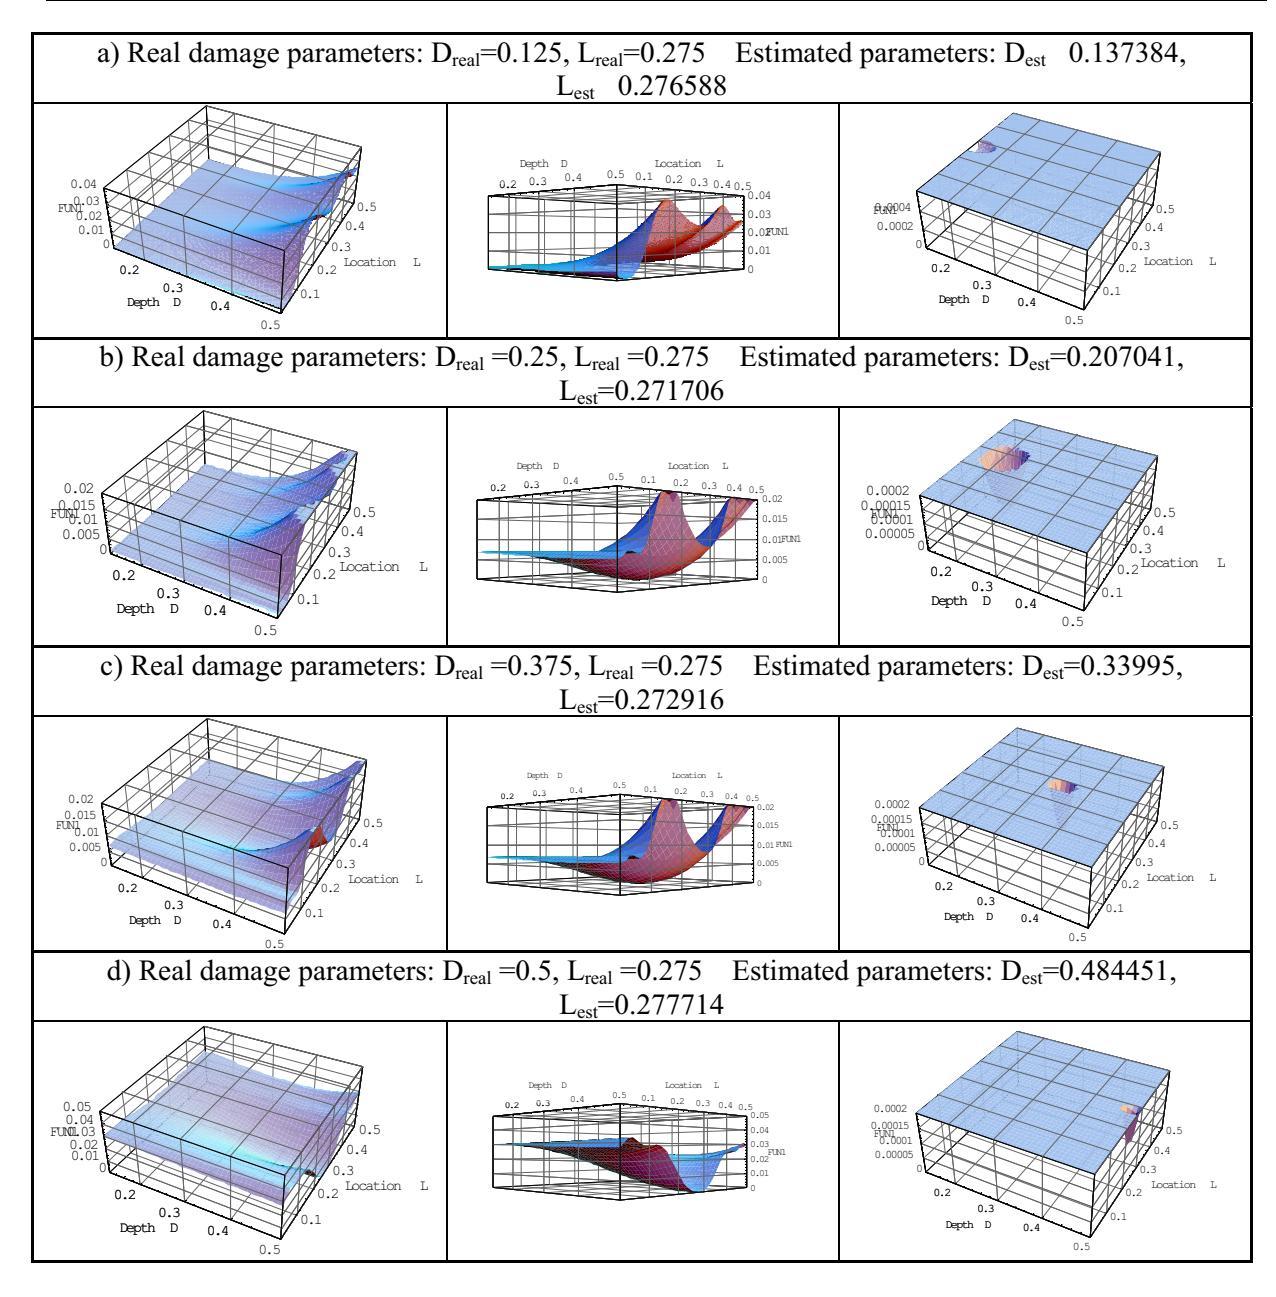
Figure 3. Graphical presentations of functional in two views and the zoomed area of functional minimum around the L_{est} and D_{est} for the numerical case $L_{real}=0.275$ and four depths of the damage

Using the calculated and measured frequencies, the minimum of the identification functional FUN(D,L) was found in software Mathematica 5.1. Figure 3 shows the results of damage identification i.e. the numerical values of L_{est} and D_{est} obtained by use of FindMin option in Mathematica 5.1 for the beam sample with $L_{real}=0.275$ and four depths of the damage. There are also graphical presentations of the functional in two views and the zoomed area of the functional minimum around the L_{est} and D_{est} .

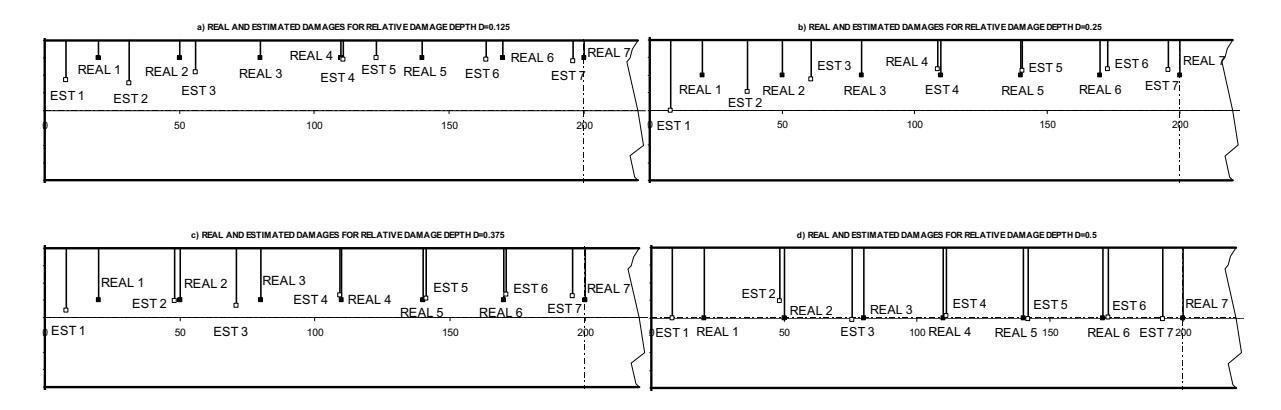
Figure 4. Damage identification results for all 28 damage scenarios

The identification procedure explained in chapter 3 was done for all 28 cases of damaged states (7 locations by 4 depths) and the results of damage identification are shown in Fig. 4.

For four cases that refers to the location of $L_{real}=0.05$, the Mathematica software couldn't find the accurate numerical values of D_{est} and L_{est} for the functional minimum but using the appropriate zoomed views, the characteristic values of D_{est} and L_{est} have been defined approximately.

The identification results on Figure 4 show that, despite all modeling and measuring errors, the results of the used identification technique are quite accurate.
