# OIL QUALITY INFLUENCE ANALYSIS ON CONDITION OF HYDRAULIC EXCAVATOR RH 120E TRIBOLOGY ASSEMBLIES

In this document, it will be presented results of experimental research which are conducted on equipment (hydrostatic power systems of hydraulic excavator RH 120E) in brown coal mine Banovici.

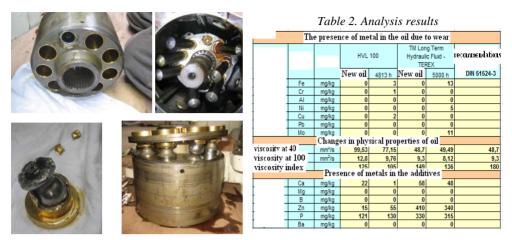
Picture 2. Damages of pump No. 2 elements

Analysis of hydraulic oil, which results are presented, was done after failure of main hydraulic pump No. 2. After disassembling damaged hydraulic axial piston pump, it was found one piston damaged, what is presented on Picture 2.

After failure of hydraulic pump No. 2, what was one of reasons for analysis of oil physical-chemical characteristics, in hydraulic system was oil HLV 100 super max (non genuine oil) which operates for 4813 working hours. In table 2 are presented results of genuine oil analysis (filled during machine assembling) and analysis of non genuine oil, manufactured in the region.

After given result of oil analysis and its comparison to limit values of individual characteristics, it was decided that complete oil in the system should be replaced. (total quantity of new filled oil 3500 lit.).

It was conducted complete analysis of damaged hydraulic pump, and it is decided that pump repair is not worth, compairing it with price of new pump (price of new axial piston pump is  $38.000 \in$ , while manufacturer offered to exchange damaged pump for new one for 50% price of new one. It is purchased and installed new pump. It is necessary to emhasize that excavator was not in operation because of pump for 336 working hours, what significantly increased total costs.
