BALLBAR QC10 MEASURING DEVICE – FAST EXPERIMENTAL CHECK OF MACHINE TOOLS ACCURACY

This paper explains basic work principle of QC10 device through the process of controlling accuracy of a DMG Monoblock 60 high speed milling machine. The machine is placed in Laboratory for Metal Cutting and Machine Tools of the University of Zenica. Two measuring, circular tests were performed on the same position on machine table. The same center of circulation with the length of extension bar of 100 mm has been utilized but with time shifts of 6 years between the tests. The obtained results have been compared based on Renishaw Ballbar analysis.

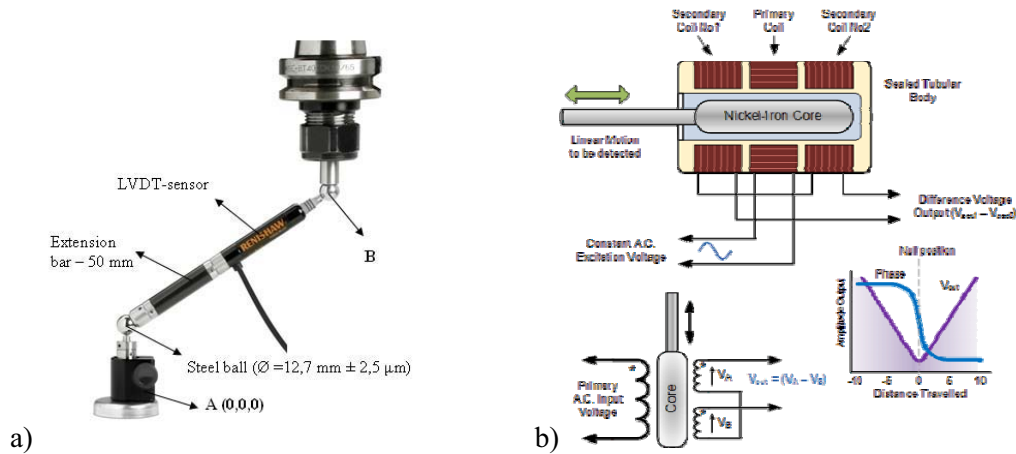
Figure 1. - (a) Ballbar QC 10 setting up, (b) LVDT (Linear Variable Differential Transformer).

The results of measurement and monitoring of dimensional and geometric errors of CNC machine tools dictates the necessary dynamics of machine maintenance. Of course, the well managed and appropriate maintenance will ultimately extend the life of exploitation of CNC machines [1]. Ballbar QC10 is measuring device produced in United Kingdom in 1991 by Renishaw. It is used for quick measuring and monitoring characteristics of CNC machine tools. Device works on the principle of measuring axial elongation of extension bar during machine circular interpolation. Main part of this device is LVDT (Linear Variable Differential Transformer) sensor shown on Figure 1b. Magnetic cup is attached on worktable and center cup is attached on main spindle of machine tool at the beginning of test, shown in Figure 1. Device works on the principle of moving steel balls that are placed on the

end of the extension bar. Through an RS 232 port (COM), the LVDT sensor is connected with computer and suitable software, which detect axial movements of one steel ball relative to the other one. According to the limits of each machine and the different types of machines, various tests can be made: circular (360°), half-circular (180°) or one quarter of a circle test (90°) in XY, XZ or YZ planes. The basic radius of the Ballbar system is 100 mm, but it can be extended with additional bars to 150, 300 or 600 mm.

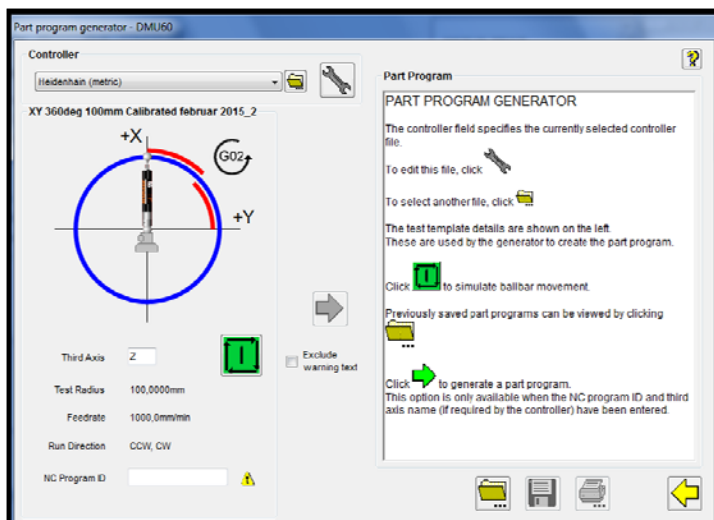
Figure 2. Ballbar test program generator

Experimental tests were carried at the Laboratory for Metal Cutting and Machine Tools (Faculty of Mechanical Engineering, University of Zenica). The tests were carried out on CNC machine tool DMU Monoblock-60. The CNC program is generated by Ballbar program generator, figure 3. First measurement had been done in 2009 and saved in machine database. The calibrated extension bar of

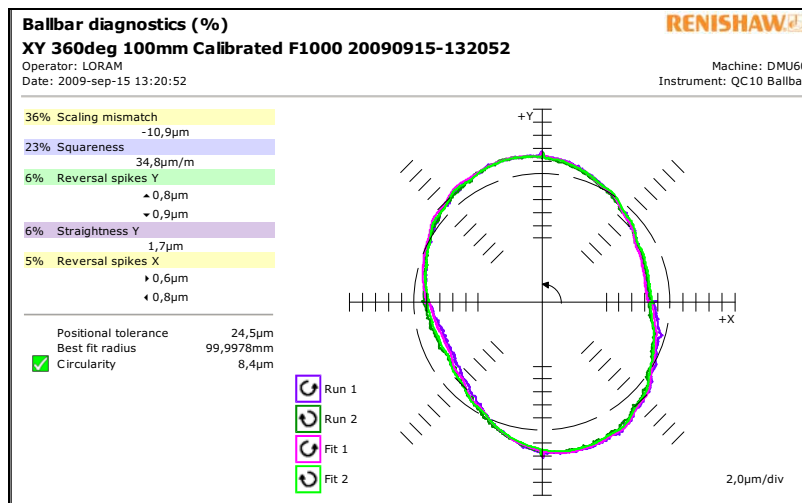
Figure 3 – Results of the test done in 2009

100 mm, XY plane and federate of 1000 mm/min has been selected for this test. The results of the test are shown in figure 3.

Obtained results for the both of the test have been shown on figure 3. and figure 4. From the presented results is obvious that the main percentage of the total machine error is due to scaling mismatch error. This type of machine error occurs when machine axes (X and Y in this case) either over traveling or under traveling relative to the other. Possible causes are: linear error compensation parameter might be set incorrectly, or the axis tape scale may be either over-tensioned or under tensioned, or the axis ballscrew may be faulty or overheating causing a ballscrew pitch error. The machine may be subject to an angular error, causing the X or Y axis to pitch out of the test plane as it moves. This is because the axis guideways are not straight or are not sufficiently rigid.

In 2009 this error takes 36% of total error, while in 2015 its contribution to total error was estimated on 33%. Yet, decreasing of the percentile contribution does not mean that absolute value of the error in 2015 is less than in 2009. On the contrary, the error is increased from 10.9 μm in 2009 to 13.6 μm in 2015. Decreasing in percentile contribution of this type of error has been followed with increasing contribution of other type of mistakes, primarily the squareness.

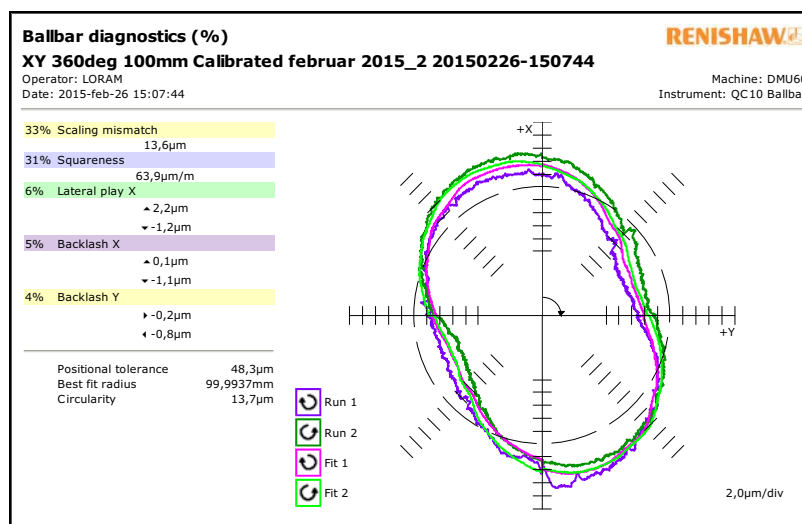
Figure 4. – Results of the test done in 2015

The same test, with same bar length, with approximately same position on worktable, in same XY plane and with identical CNC program has been repeated in February 2015. The results of this test are given in figure 4.

The squareness error is detected when X and Y axes of the machine are not at 90° to one another at the position on the machine where the test is being performed. The axes may be bent locally or there may be an overall axis misalignment in the machine. In both of the analyzed cases the squareness is the second most important type of error. In 2009, the squareness percentile contribution is 23% of

total error. Its estimated values was 34,8 $\mu\text{m}/\text{m}$. In 2015, the same error contributes with 31% of the total error. But comparing the absolute values this error in 2015 is almost doubled with values of 63,9 $\mu\text{m}/\text{m}$. These results indicate that the machine guideways may be worn slightly during the time causing a certain amount of play in the axes when they move. The effect of a squareness error is that machined faces cut by the machine will not be ideally squared.

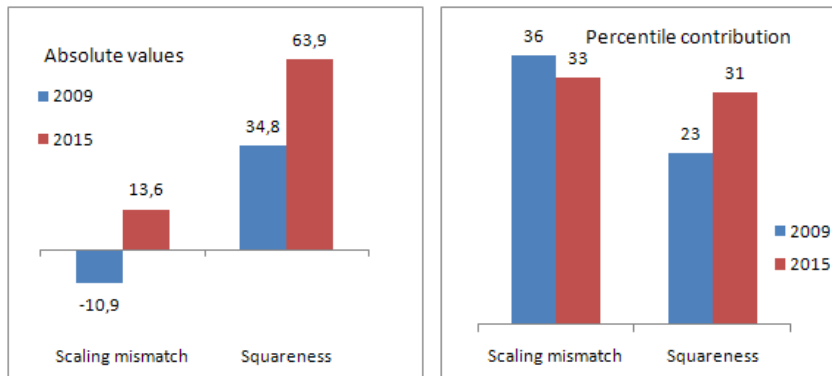
Figure 5. Diagrams of main errors distribution

In both analyzed cases described two type of the errors contribute about 2/3 of total machine error. The rest of the accuracy deterioration is caused by other types of errors like: lateral play, backlash, straightness, reversal spikes, servo mismatch, cyclic error etc.

In 2009 the errors are reversal spikes Y, straightness Y and reversal spikes X. None of these are essentially related to wearing process – worn guideways etc.

In 2015 the rest of the errors are: lateral play X, backlash X and backlash Y. Unlike to 2009, the errors in 2015 are actual consequence of the wearing process. For example, the main cause of lateral play is play or slop in machine guideways. This allows the axes of the machine to move at right angles to their guideways as the axis reverses. This should be contrasted with a backlash step, which is also caused by play, but in line with the axis. As seen on a Ballbar circular test, backlash is a radial error, whereas lateral play is a tangential error.
